# A simulated bushfire test report

Test standard: Clauses 14 and 16 of AS 1530.8.1:2018

Products: Breezway® Altair® Louvre in an Easyscreen™ Window System

Breezway® Altair® IGLU® Louvre in an Easyscreen™ Window System

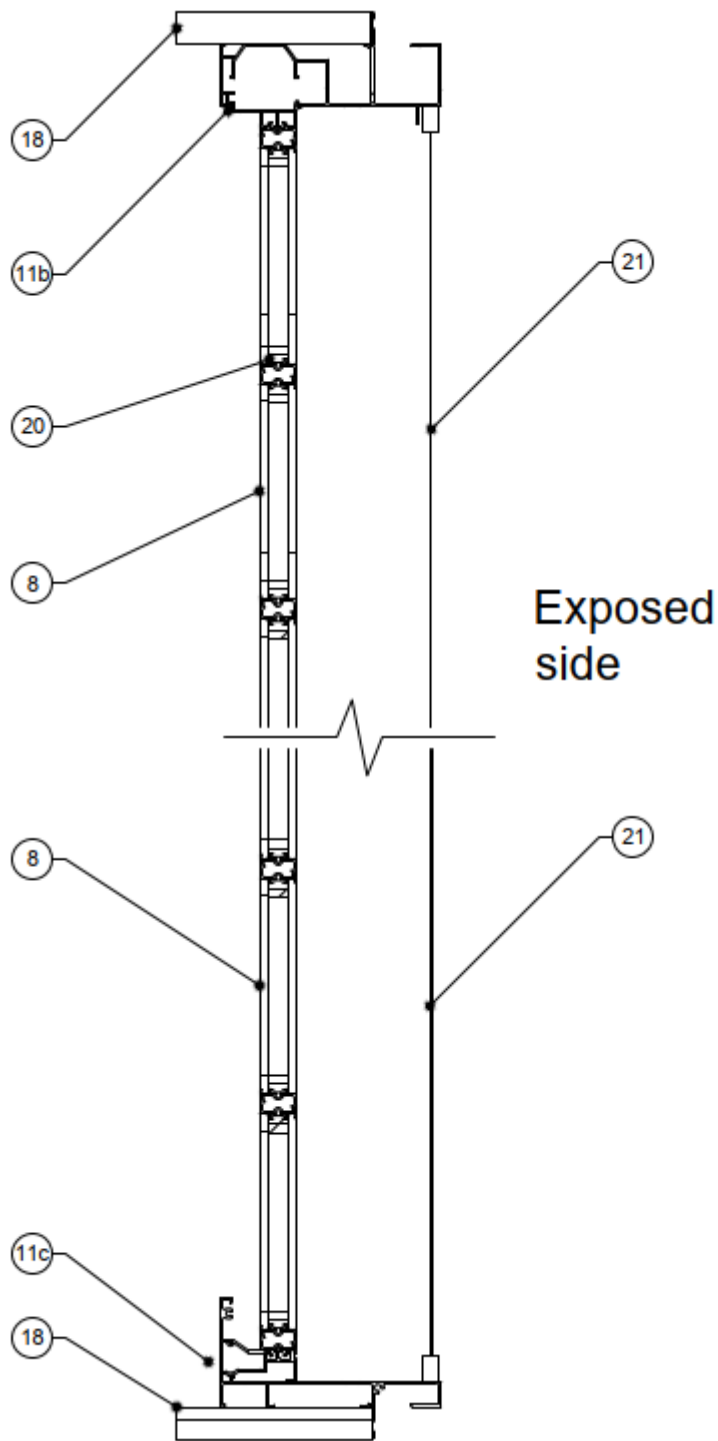
Figure 4 Vertical cross section A-A

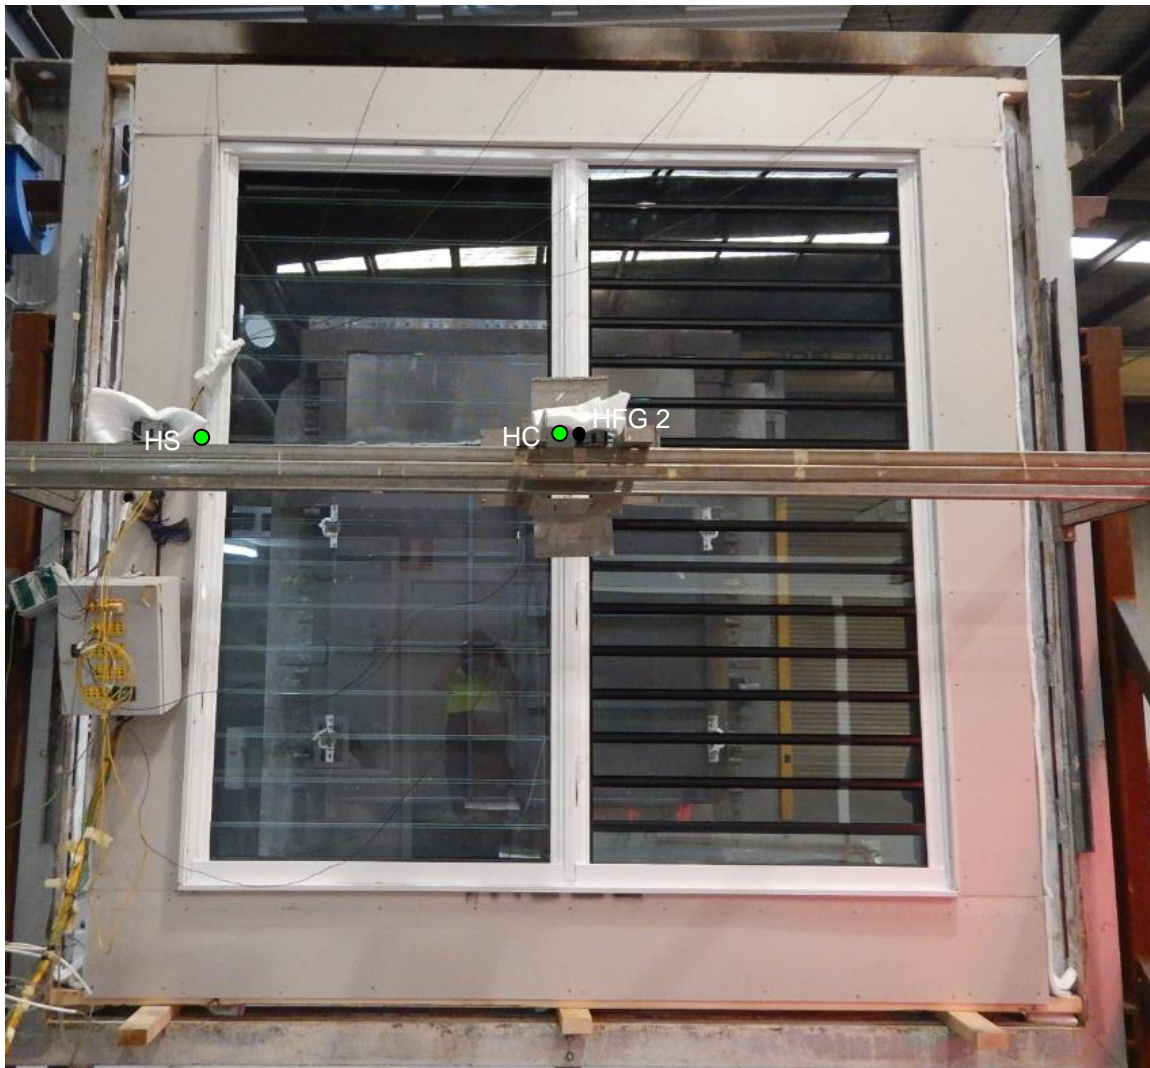
- Black dot shows heat flux gauge location.
- Green dots show deflection locations.

**Figure 7 Heat flux gauge and deflection locations (unexposed side shown)**

Item	Detail
	<ul style="list-style-type: none"> <li>During the test, the heat flux gauge that was in the south wall section at a height of 2265 mm from the floor remained in place, using values found during an ancillary pre-test calibration to determine the heat flux at the leading edge of the glazing.</li> <li>During the test, second and third heat flux gauges were centrally located next to the glazed elements of the specimen – at a distance of 365 mm behind the unexposed face of the specimen and 250 mm in front of the exposed face of the specimen. This was to determine the transmission of radiative flux through the specimen during the test, and to determine the radiant heat flux 250 mm from the exposed side of the specimen during the 20 to 60 minutes periods of the test.</li> <li>The heat flux gauge positions are shown in Figure 7 in Appendix E.</li> </ul>

Location	Ref	Description
Framing	HS	Mid-height of the south jamb
	HC	Mid-height of the centre coupler

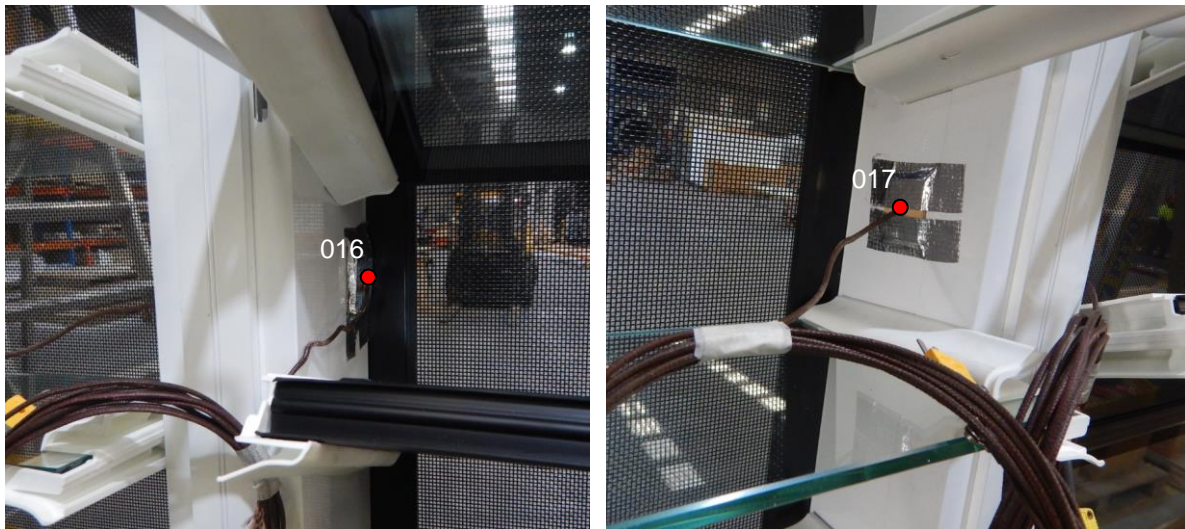
- Red dots show thermocouple locations.

**Figure 8 Thermocouple locations (unexposed side shown)**

Location	T/C #	Description
Eave	011	Internal surface of the eave above the south crib.
	012	Internal surface of the eave above the centre of the south louvre system
	013	Internal surface of the eave above the centre crib.
	014	Internal surface of the eave above the centre of the north louvre system
	015	Internal surface of the eave above the north crib.
Frame coupler	016	On the north face of the centre coupler, at mid-height and 15 mm from the security screen
	017	On the south face of the centre coupler, at mid-height and mid-depth of the coupler.

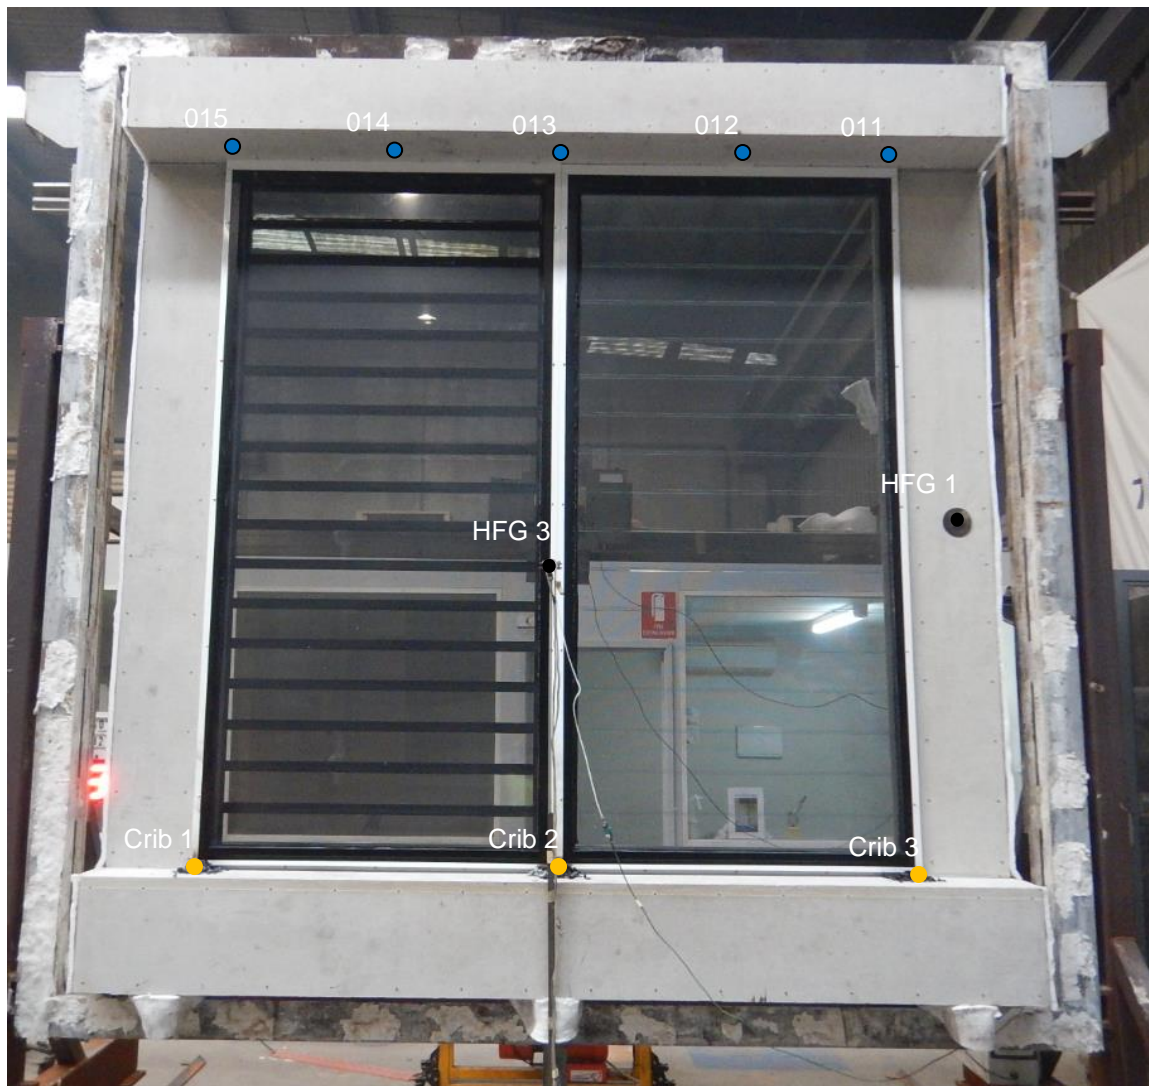
- Northern crib located at the north jamb.
- Southern crib located at the south jamb.
- Centre crib located at the sill adjacent to the centre coupler.
- Blue dots show internal thermocouple locations.
- Black dots show heat flux gauge locations.
- Orange dots show crib locations.

**Figure 9 Instrumentation locations (exposed side shown)**

Location	Ref	Description
Wall	HFG 1	Located at the mid-height of the specimen at 250 mm from the southern edge, on the exposed face.
Glazing	HFG 2	Located at the centre of the specimen, 365 mm behind the glazing on the unexposed face.
	HFG 3.	Located at the centre of the specimen, 250 mm in front of the glazing on the exposed face. The heat flux gauge was put into position after 20 minutes.

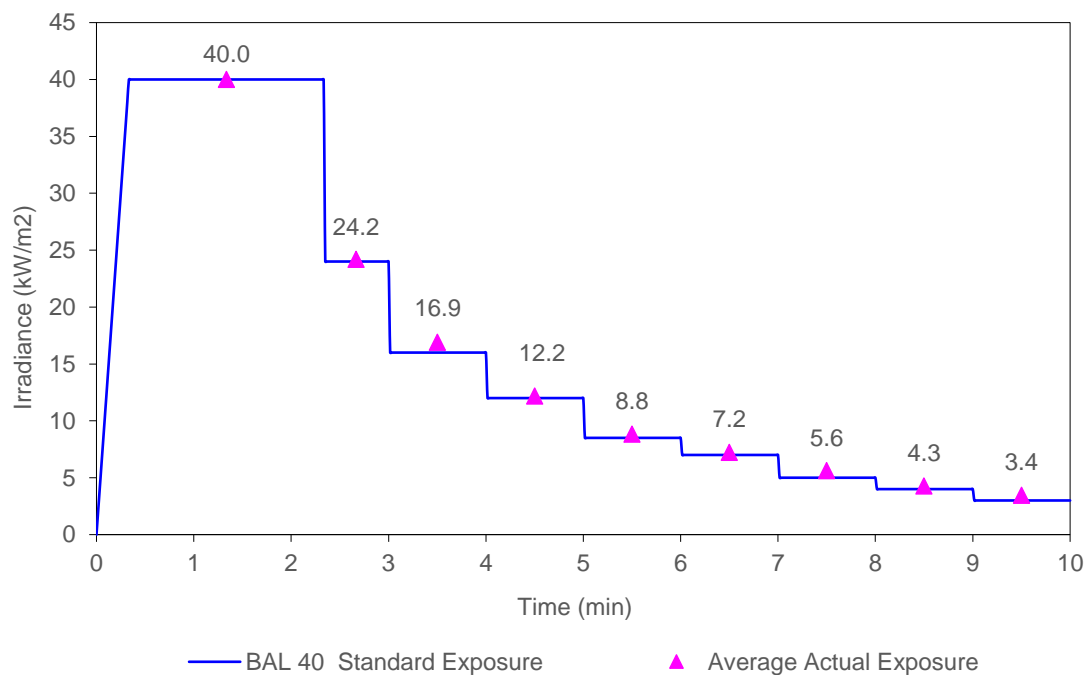
Figure 11 Averaged irradiance levels during the test to the glazing

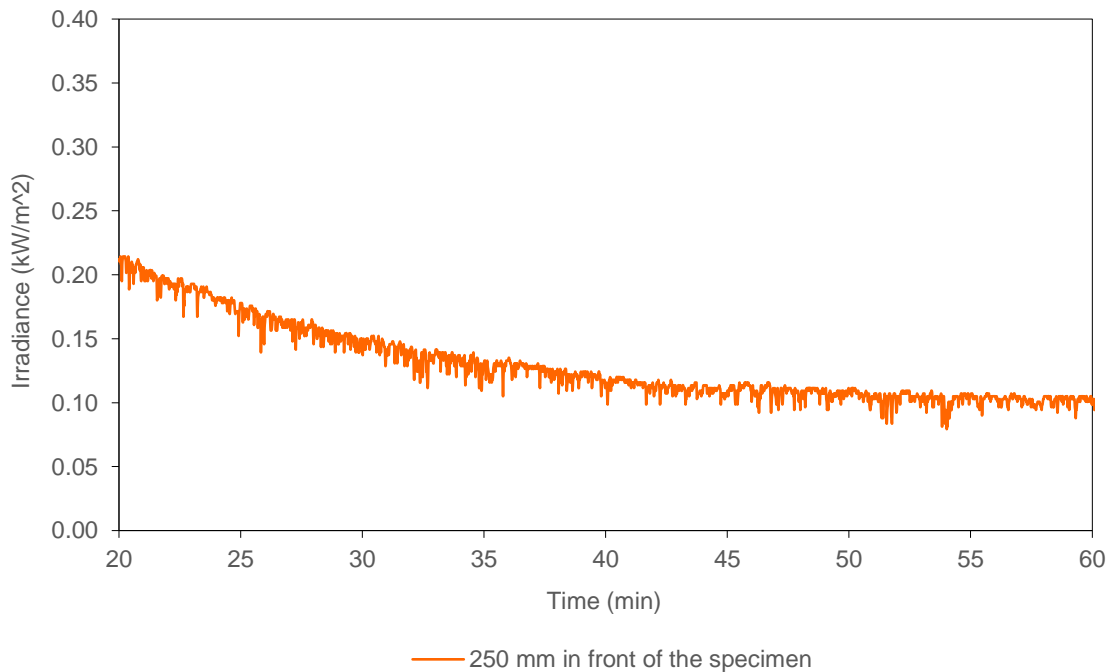
Figure 13 Radiant heat flux received 250 mm in front of the specimen

Less than 21 kW/m<sup>2</sup> heat flux radiation was received by the heat flux gauge positioned centrally to the front of the specimen and 250 mm from the glazing during the time period of 20 to 60 minutes of the test period.

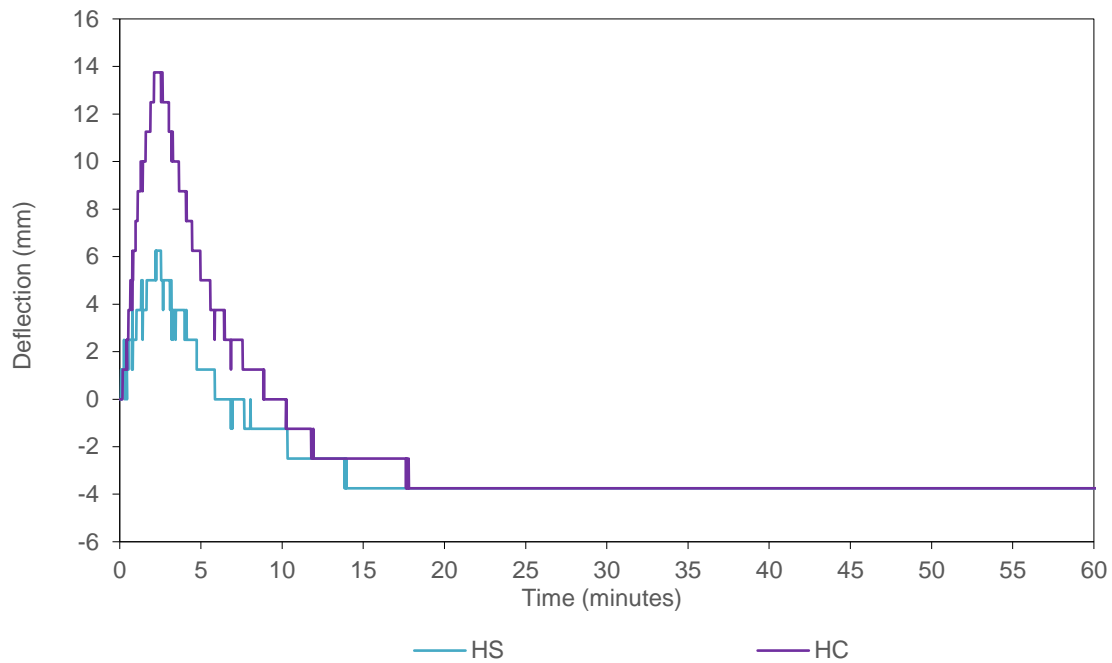
- Positive measurements show movement of the test specimen towards the radiant heat panel.
- Negative measurements show movement of the test specimen away from the radiant heat panel.

**Figure 16** Deflection of the test specimen vs time – horizontal deflection

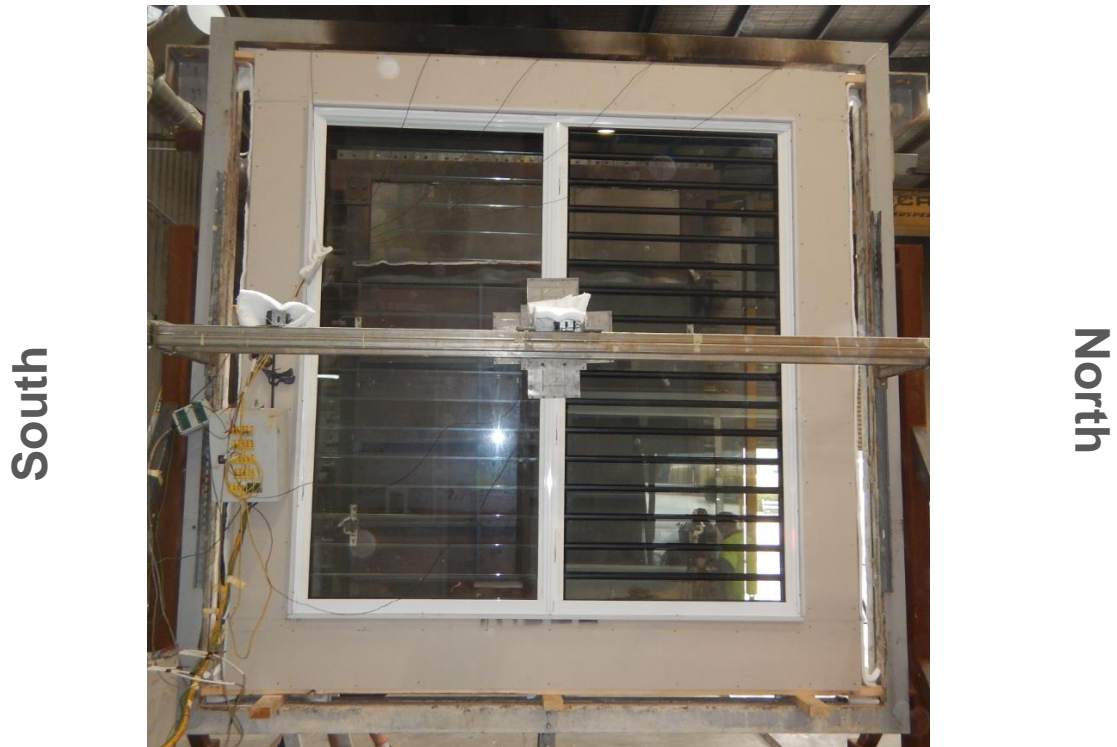
Figure 17 Unexposed face of the specimen before the start of the test

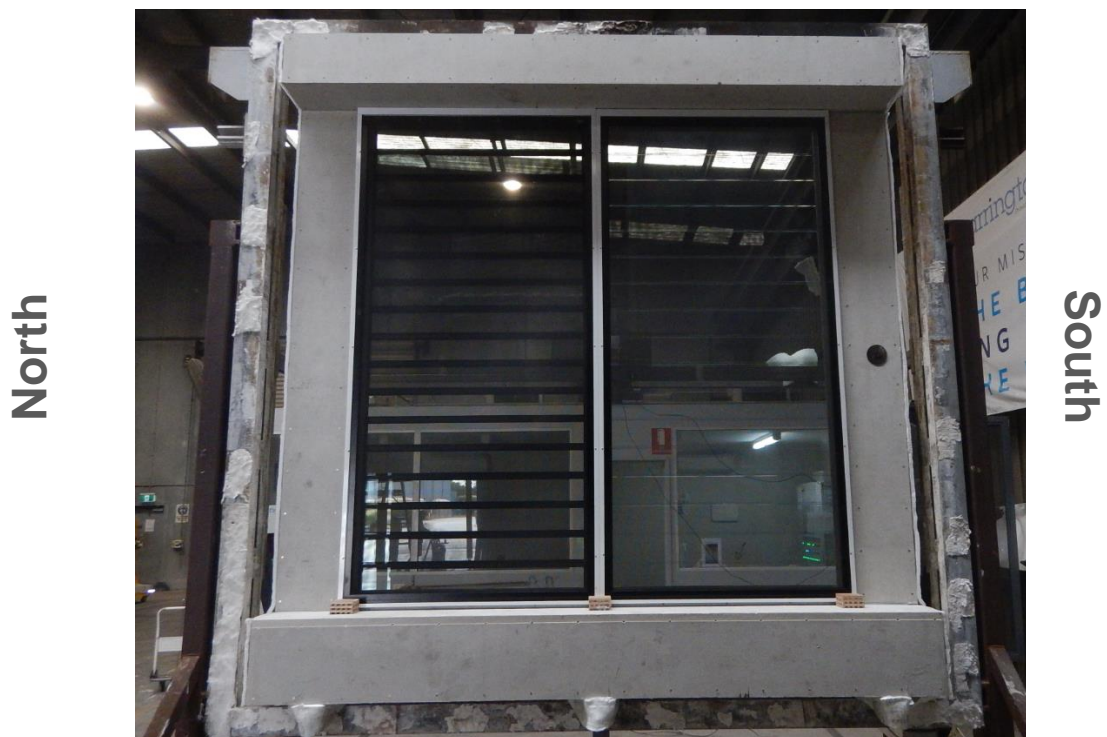
Figure 18 Exposed face of the specimen before the start of the test

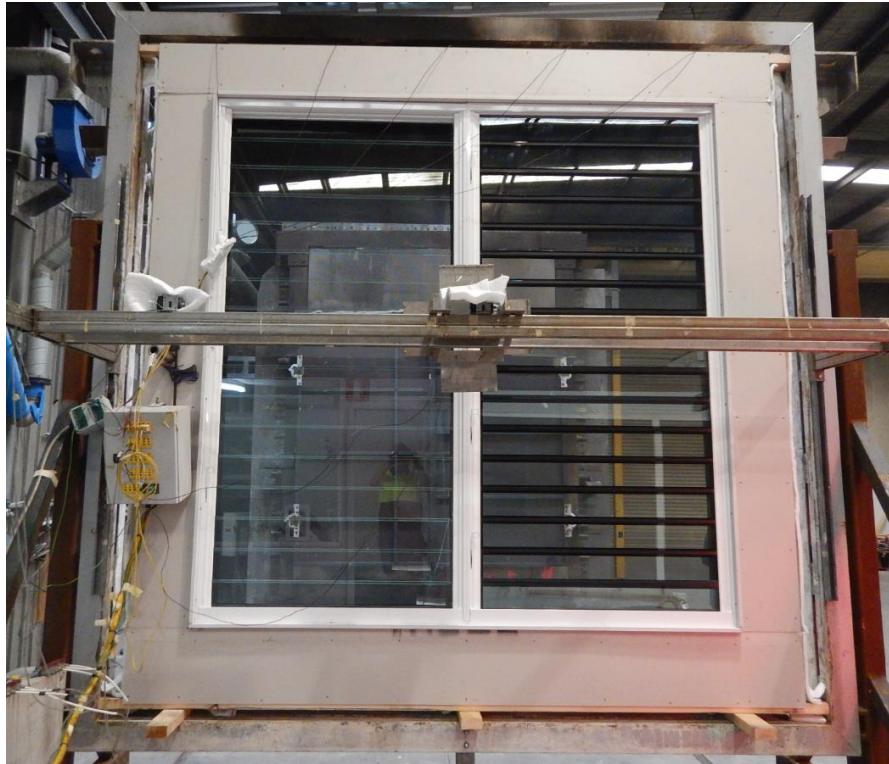
Figure 19 Unexposed face of the specimen at the end of the test

Time		Observation
Min	Sec	
00	00	The simulated bushfire radiant heat test started. Three flaming cribs (class AA) were placed against the test specimen. The ambient temperature of the laboratory was approximately 25 °C.
00	04	The screen shielding the specimen from the radiant heat was removed and the test specimen was exposed to the radiant heat profile for BAL 40, as specified in AS 1530.8.1:2018.
00	42	The security screens were both bending towards the radiant heat panel.
01	14	Smoke was emitting from the exposed side of both security screens, between the mesh and the screen frame.
10	00	The screen was re-positioned in front of the furnace shielding the specimen from the radiant heat and exposure to the radiant heat profile of BAL 40 was stopped. Monitoring of the test specimen against the performance criteria outlined in AS 1530.8.1:2018 continued.
60	00	No further changes to the specimen. Test was stopped in accordance with the procedure outlined in AS 1530.8.1:2018.

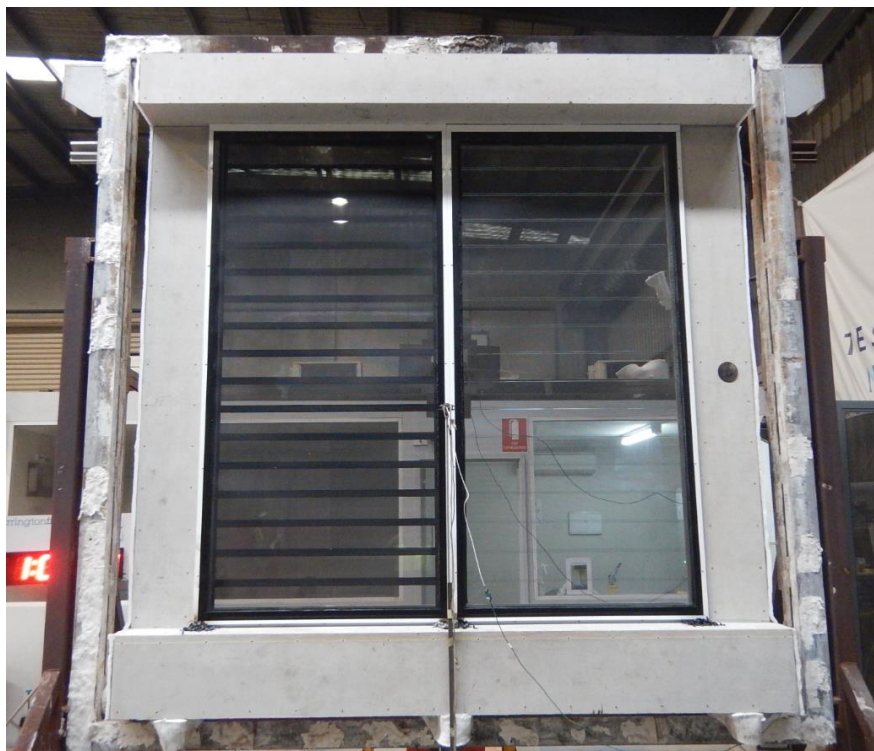
Figure 20 Exposed face of the specimen at the end of the test
